# Afraid of the Dark?

We'll examine the effect of severe black pad defect on solder bonds on BGAs.

Robert F. Champaign, Jodi A. Roepsch  
and Marlin R. Downey

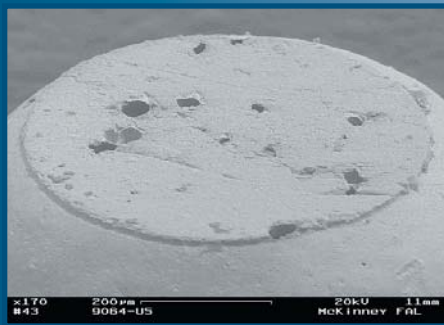
**FIGURE 1:** SEM image of a ball attachment interface following separation.

• **Component Failure.** Mechanical shock resulted in separation of the BGA from the CCA at the ball-to-BGA pad interfaces. The top of the balls and bottom of the BGA component substrate pads

were extremely flat, which suggested a brittle failure mechanism at the Sn63Pb37 solder to electroless nickel interfaces (Figure 1). The damage is at the tin/lead (Sn/Pb)-to-nickel interface with no evidence of stress to the remainder of the component body or the circuit card.

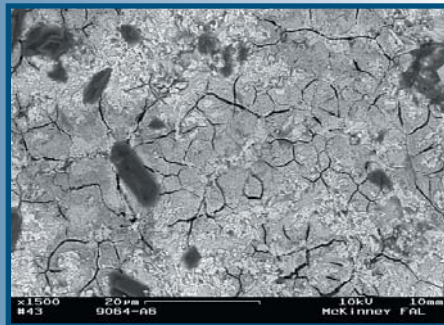
**FIGURE 2:** Mud-cracked appearance of the surface is characteristic of black pad defect.

• **Black Pad Defect.** SEM analysis of the exposed pad surface on the failed BGA demonstrated *mud cracking*, which is characteristic of severe black pad as shown in the SEM image in Figure 2. The mud-cracked appearance is a result of the corrosion spiking as nickel is depleted from the electroless nickel during the immersion gold plating process. Figure 3 is a backscattered electron FE-SEM image of another pad surface.

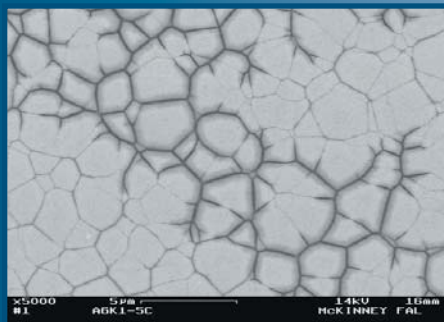
**FIGURE 3:** Image of a surface with black pad that has been cyanide etched to remove the gold. The black region around the nickel nodules contains a high phosphorus content. The surface has an obvious mud-cracked appearance.

The BGA did not yet have the solder balls bonded to the pad surface. The gold was removed with a cyanide etch. This surface also has a mud-cracked appearance. The dark region surrounding the nickel nodules is the high phosphorus content due to the corrosion spiking along the nickel grains.

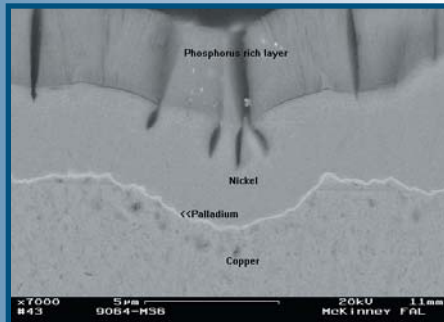
**FIGURE 4:** Large region of severe black pad with spikes protruding into nickel layer.

Micro sections of the failed part revealed many areas across the surface of the pads where corrosive spikes were found that extended well into the nickel layer. Figure 4 is a backscattered electron image of the black pad defect in cross section. The dark layer is due to the increased phosphorus content in comparison to the rest of the electroless nickel. The phosphorus-rich zone consumes about half of the electroless nickel layer, which is excessive in comparison to a normal solder joint. In a normal solder joint, the phosphorus-rich layer would be just at the solder to Ni/P plating interface.

Phosphorus levels were determined by EDS standardless quantitative analysis. The phosphorus measured approximately 17.4 weight percent (wt%) in the black pad corrosion area, as compared to a 7.4 wt% in the bulk electroless nickel. This phosphorus level increase, as a result of nickel depletion, is greater than two times the level in the bulk nickel. Some formation of a phosphorus-rich zone is normal when a good solder bond is formed due to the depletion of nickel from the formation of Ni/Sn intermetallics.

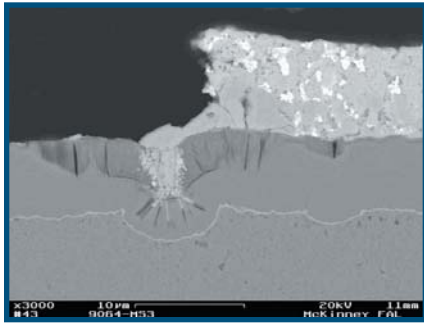
**FIGURE 5:** Area of severe black pad and corrosion spikes provided a connecting path between the solder and the copper below the nickel layer.

since the solder balls were bonded to an electroless nickel pad. Cross-sectional examination determined the Cu/Sn intermetallics at the fracture interfaces were the result of severe black pad and the formation of corrosion crevices completely through the nickel layer. The deep spikes in the nickel created a path between the solder and the underlying copper layer allowing Cu/Sn intermetallics to form at the interface (Figures 5 and 6).

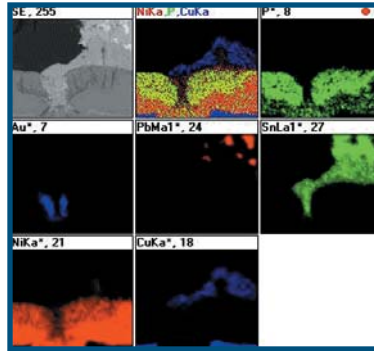
**FIGURE 6:** EDS elemental dot map showing Cu/Sn intermetallic formation through the black pad corrosion spikes in the nickel layer. The Cu/Sn intermetallics have formed on the pad surface above the nickel layer. Gold is still present on the walls of the large spike through the nickel layer.
