# Optimizing Processes and Materials for Flip Chip Reliability

Karl-Friedrich Becker and Tom Adams

Careful material selection can yield FC assemblies with better reliabilities than some surface-mount components.

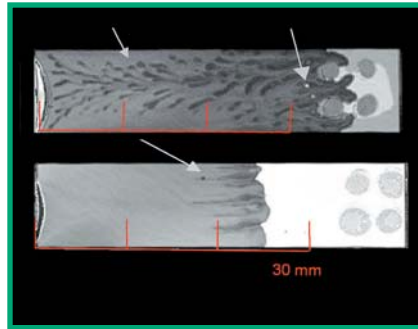
**FIGURE 1:** Post-cure C-SAM acoustic image of flow module testing of Materials A and C. Direction of flow of the underfill is from the left. Arrows point out dark regions (particle agglomeration) and bright regions (trapped air).

Empirical testing of flow behavior was carried out with the flow module test vehicles and the actual flip chip assemblies described earlier. A video camera recorded the flow process in the test vehicle; post-cure, both the test vehicles and the flip chip assemblies were inspected by acoustic micro imaging (Figure 1), followed by physical sectioning where significant defects were present.

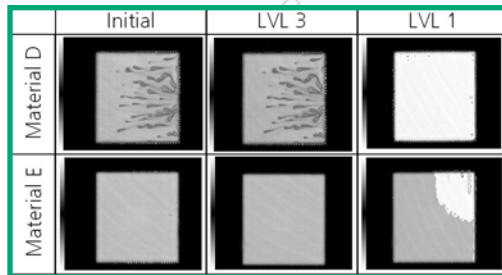
**FIGURE 2:** C-SAM acoustic images of flip chip assemblies for Materials D and E during popcorn testing. At right, Material D is 100% delaminated, while Material E is 30% delaminated.

The assemblies were tested for popcorn cracking according to JEDEC Std. 20, Levels 1 and 3. This testing typically caused delaminations (Figure 2), all of which resulted in electrical failures when the bump material moved into the gap created by the delamination (Figure 3).

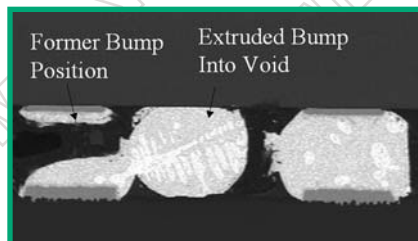
**FIGURE 3:** Cross section of an assembly after popcorn testing, showing the extrusion of the bump material into an adjacent void.

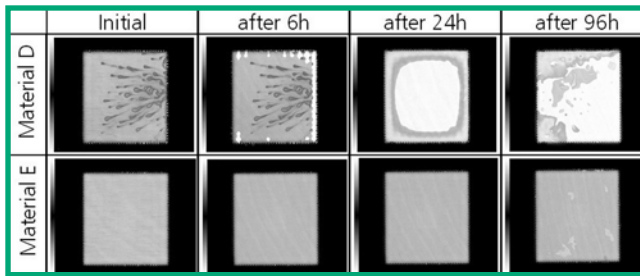
**FIGURE 4:** C-SAM acoustic images of test assemblies for Materials D and E during the course of pressure cooker testing. In Material D, delaminations began after six hours; in Material E, delaminations are just beginning after 96 hours.

Pressure cooker testing was carried out at 121° C and 100% relative humidity (RH). The typical failure was a delamination between the chip's passivation layer and the underfill. Not all of these delaminations resulted in immediate electrical failures, probably because humidity testing puts little mechanical load on the assemblies. But delaminated assemblies subjected to thermal cycling tended to fail after only a few cycles (Figures 4, 5).

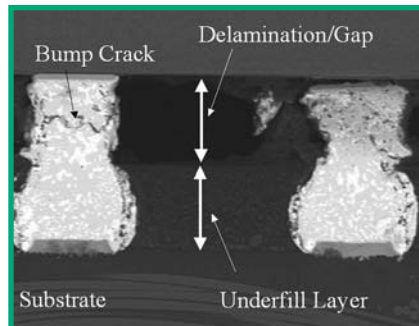
**FIGURE 5:** Cross-sectional view of an assembly using Material C after pressure cooker testing showed a significant gap between the chip and the underfill, perhaps related to the high humidity uptake of this material. Note the crack in the bump at left.

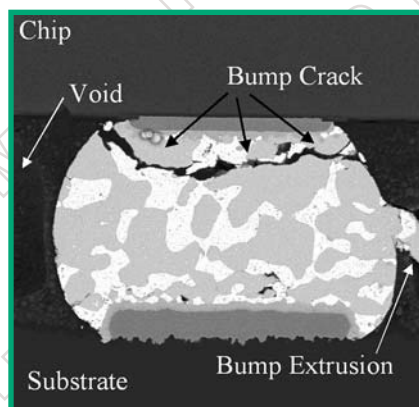
**FIGURE 6:** Failure during thermal cycling testing of Material C on Solder Mask 1: Bump material has been extruded into an adjacent void, and the bump itself is cracked. A second void is at left.

underfill, as well as resulting cracks in solder bumps and electrical failure (Figure 6). In addition, a few cracks were found at the interface between the substrate and the solder bumps. The cracks extended into the substrate.
